VESTAX AC-20 EU / AC-20 US POWER SUPPLY ADAPTER

PROBLEM

AC20 PLUG countermeasure

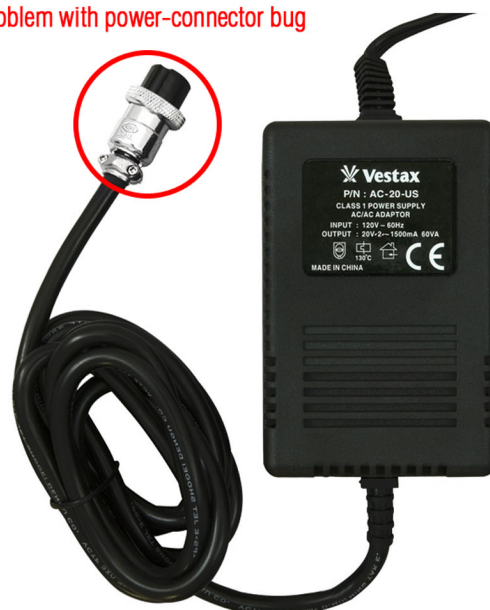
problem with power-connector bug

There is a possibility that one of the screws in the adaptor connector to the mixer becomes loose due to possible tension and excessive pulling on the outer cables, and therefore the screw may short circuit the terminal.

As a result, the transformer may heat-up to cause various other problems in the adapter. There is no affect to the product itself so the issue can be resolved by either replacing or repairing the adapter.

1. Insulating the solder terminals inside the connector by plastic tubes or glue
2. Glue the inside screw to the insulating material, so it can't come off.
3. Add some tape or tube underneath the connector's cable clamp, so the cable cannot be pulled out of the connector.
